# *Crescent Lake*

## *NPS Watershed Protection Project*

### *2011 - 2013*

Report Prepared by Patrick Marass, FB Environmental Associates

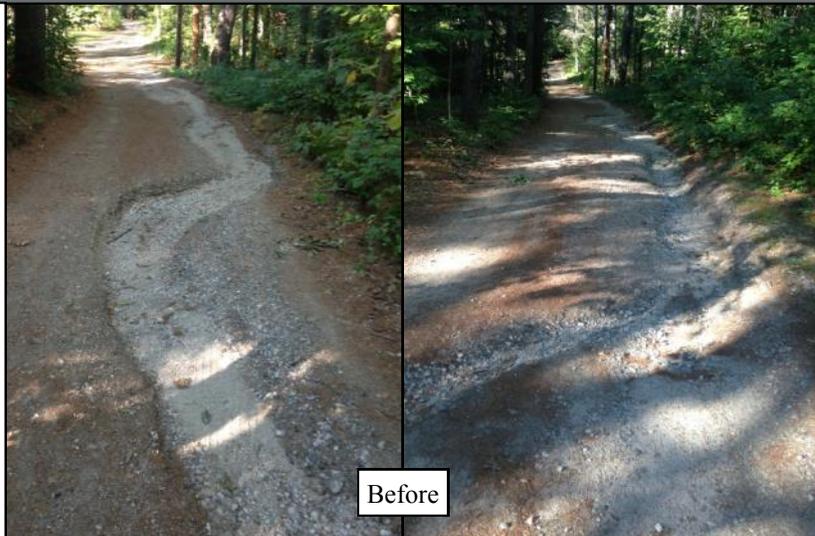
Before photo (above) show a section of Haskell Avenue that had severe erosion issues. The road used too wash out and the sediment laden stormwater would travel down a right of way and into Crescent Lake. The photos below show the road after construction. The road was re-graded, new surface material was brought in and turnouts were installed to encourage the stormwater to run into existing vegetation, which greatly reduced the sediment and phosphorus transport into Crescent Lake from the site.

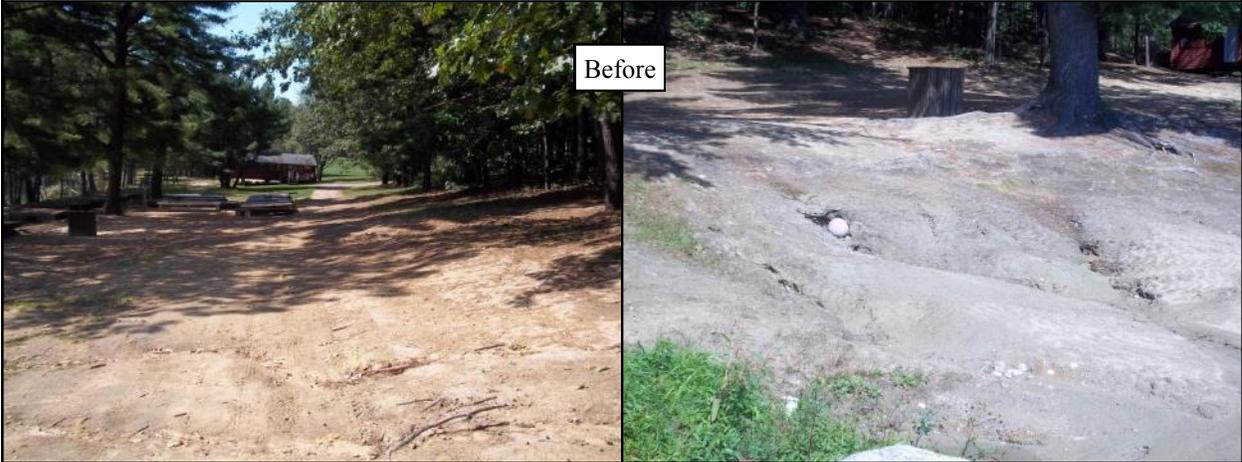
## Laurel - 1 & 2 - Photos

Before photos (above) shows the eroding swimming beach area at Camp Laurel South. Water would flow from the hill behind the beach, across bare soil, and erode the beach area carrying sediment and phosphorus directly into Crescent Lake. Construction and after photos (below) display the work that was completed to address the erosion at these sites. A large drainage swale was constructed at the bottom of the hill to carry water away from the beach area and into existing vegetation and large boulders were placed in gullies on the beach area. Erosion control mulch (ECM) was spread over the bare soil areas. Finally, plantings were installed along the top of the beach area and a large rain garden was constructed to reduce erosion and infiltrate the stormwater runoff from the site.

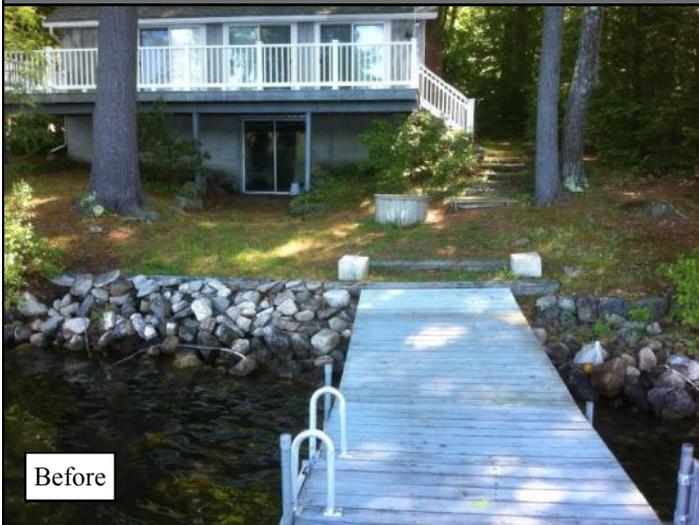
Before

This property on Hancock Road was lacking a buffer (above) and had erosion issues at the shoreline and underneath the deck. The landowner and volunteers planted over 20 shrubs along the shoreline (below left), installed several water diverters, and spread ECM underneath the deck (below right). Following this work and other landowner improvements, the property was recommended for a LakeSmart certification!

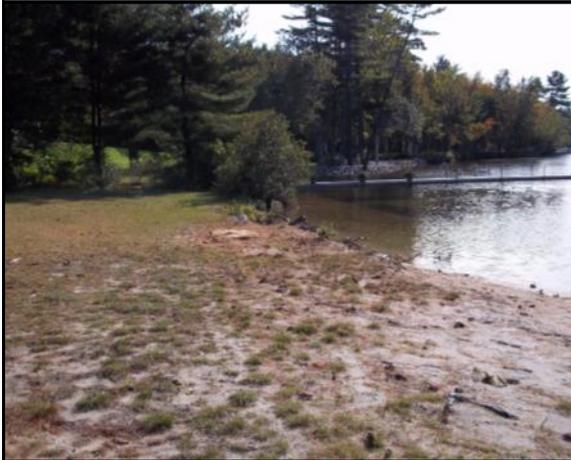
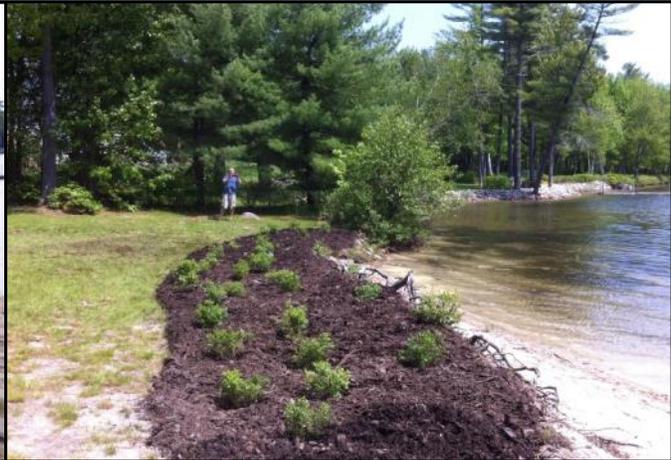
This property off Edwards Road in Casco had a large lawn leading to a bare shoreline (above left). The lack of vegetation along the shoreline was leading to some shoreline erosion over time. The landowner, along with volunteers, installed over 30 blueberry bushes and spread ECM along the shoreline to enhance the buffer and protect the shoreline and the landowner's property (above right).

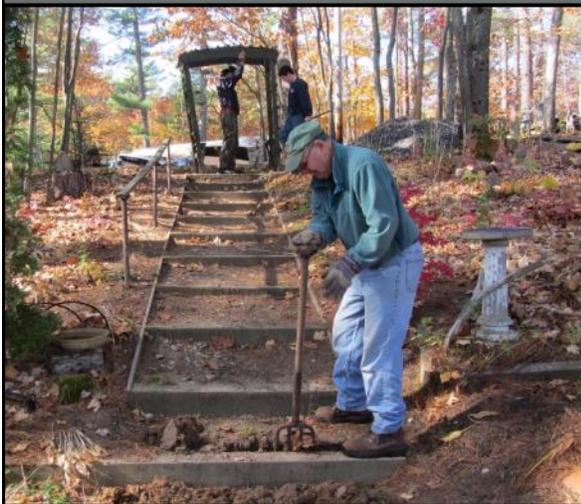
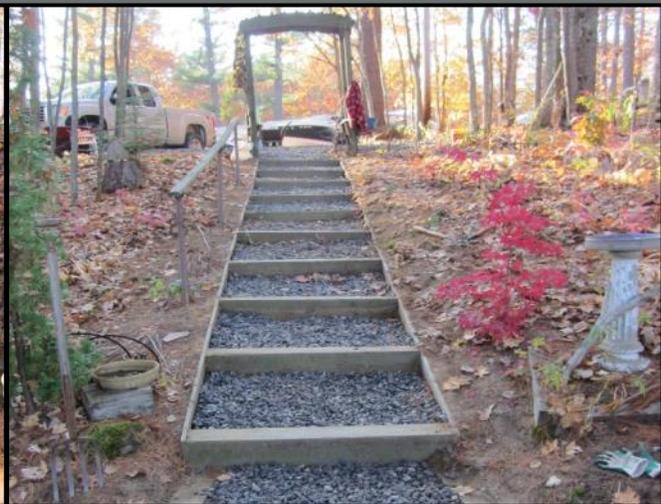
This property off Haskell Avenue had stormwater from the road flowing across their parking area, down their steps, and across their property to Crescent Lake (above left). The landowners, along with several volunteers retrofit the existing steps into infiltration steps, installed a dripline trench, spread crushed stone in the parking area and installed a water diverter to send the road runoff into existing vegetation.
